# Manhole Inspection Summary

Manhole # S23MM\_009MH

Insp Date: **7/4/05 6:23 PM**

**Location** Address: **2520 FRANCIS ST**

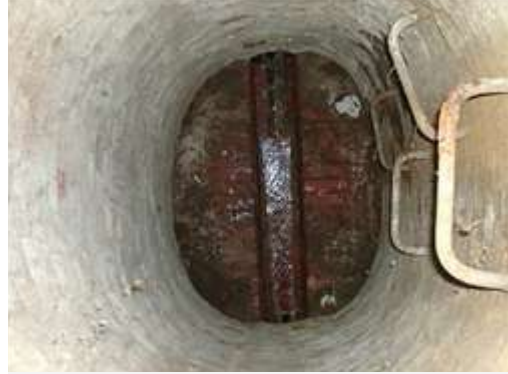
Top View

Barrel infiltration. Corroded steps.  
Evidence of surcharge - Bench debris.

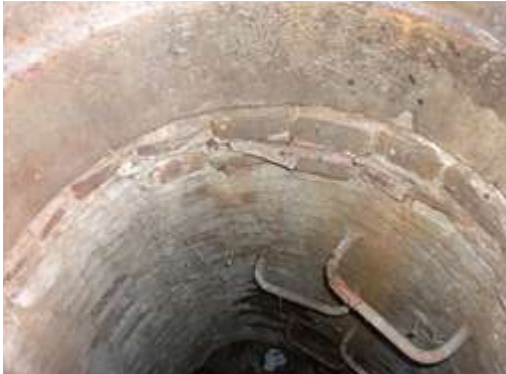
Defect

Frame leaks. Adjustment deterioration  
and infiltration. Barrel infiltration.

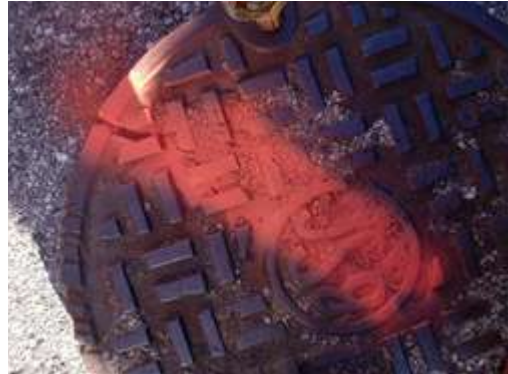
Defect

Cracked lid.

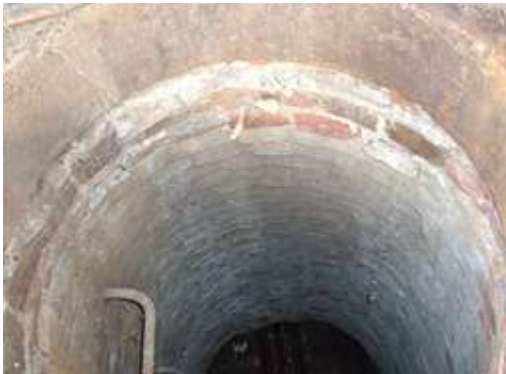
Defect

Frame leaks. Adjustment deterioration  
and infiltration.

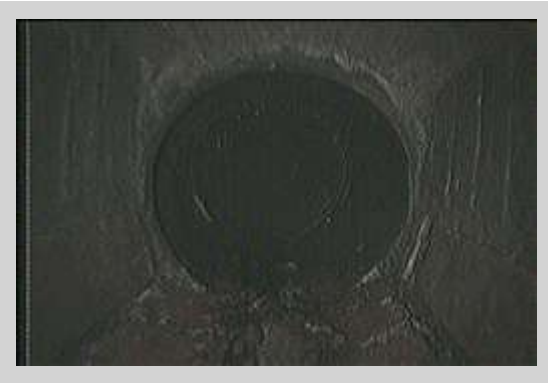
### 8 in. Circular Gravity Sewer Pipe Out @ 12 O'Clock

Channel deterioration.

Infiltration: **Evidence** Pipe Seal Cond: **Unknown**

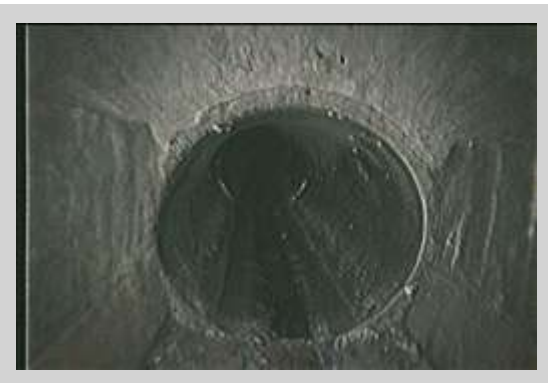
### 8 in. Circular Gravity Sewer Pipe In @ 6 O'Clock

Deposits: ☐ None ☐ Mud ☐ Sludge ☐ Debris ☒ Grease

Silt Depth: **0** (in.) Deposits Extent: **Light**
